GREAT NEAPOLITAN EARTHQUAKE OF 1857.

OBSERVATIONAL SEISMOLOGY

TO INVESTIGATE THE CIRCUMSTANCES OF THE GREAT
EARTHQUAKE OF DECEMBER 1857.

ROBERT MALLET, C.E., F.R.S., F.G.S., M.R.I.A.,
&c., &c.

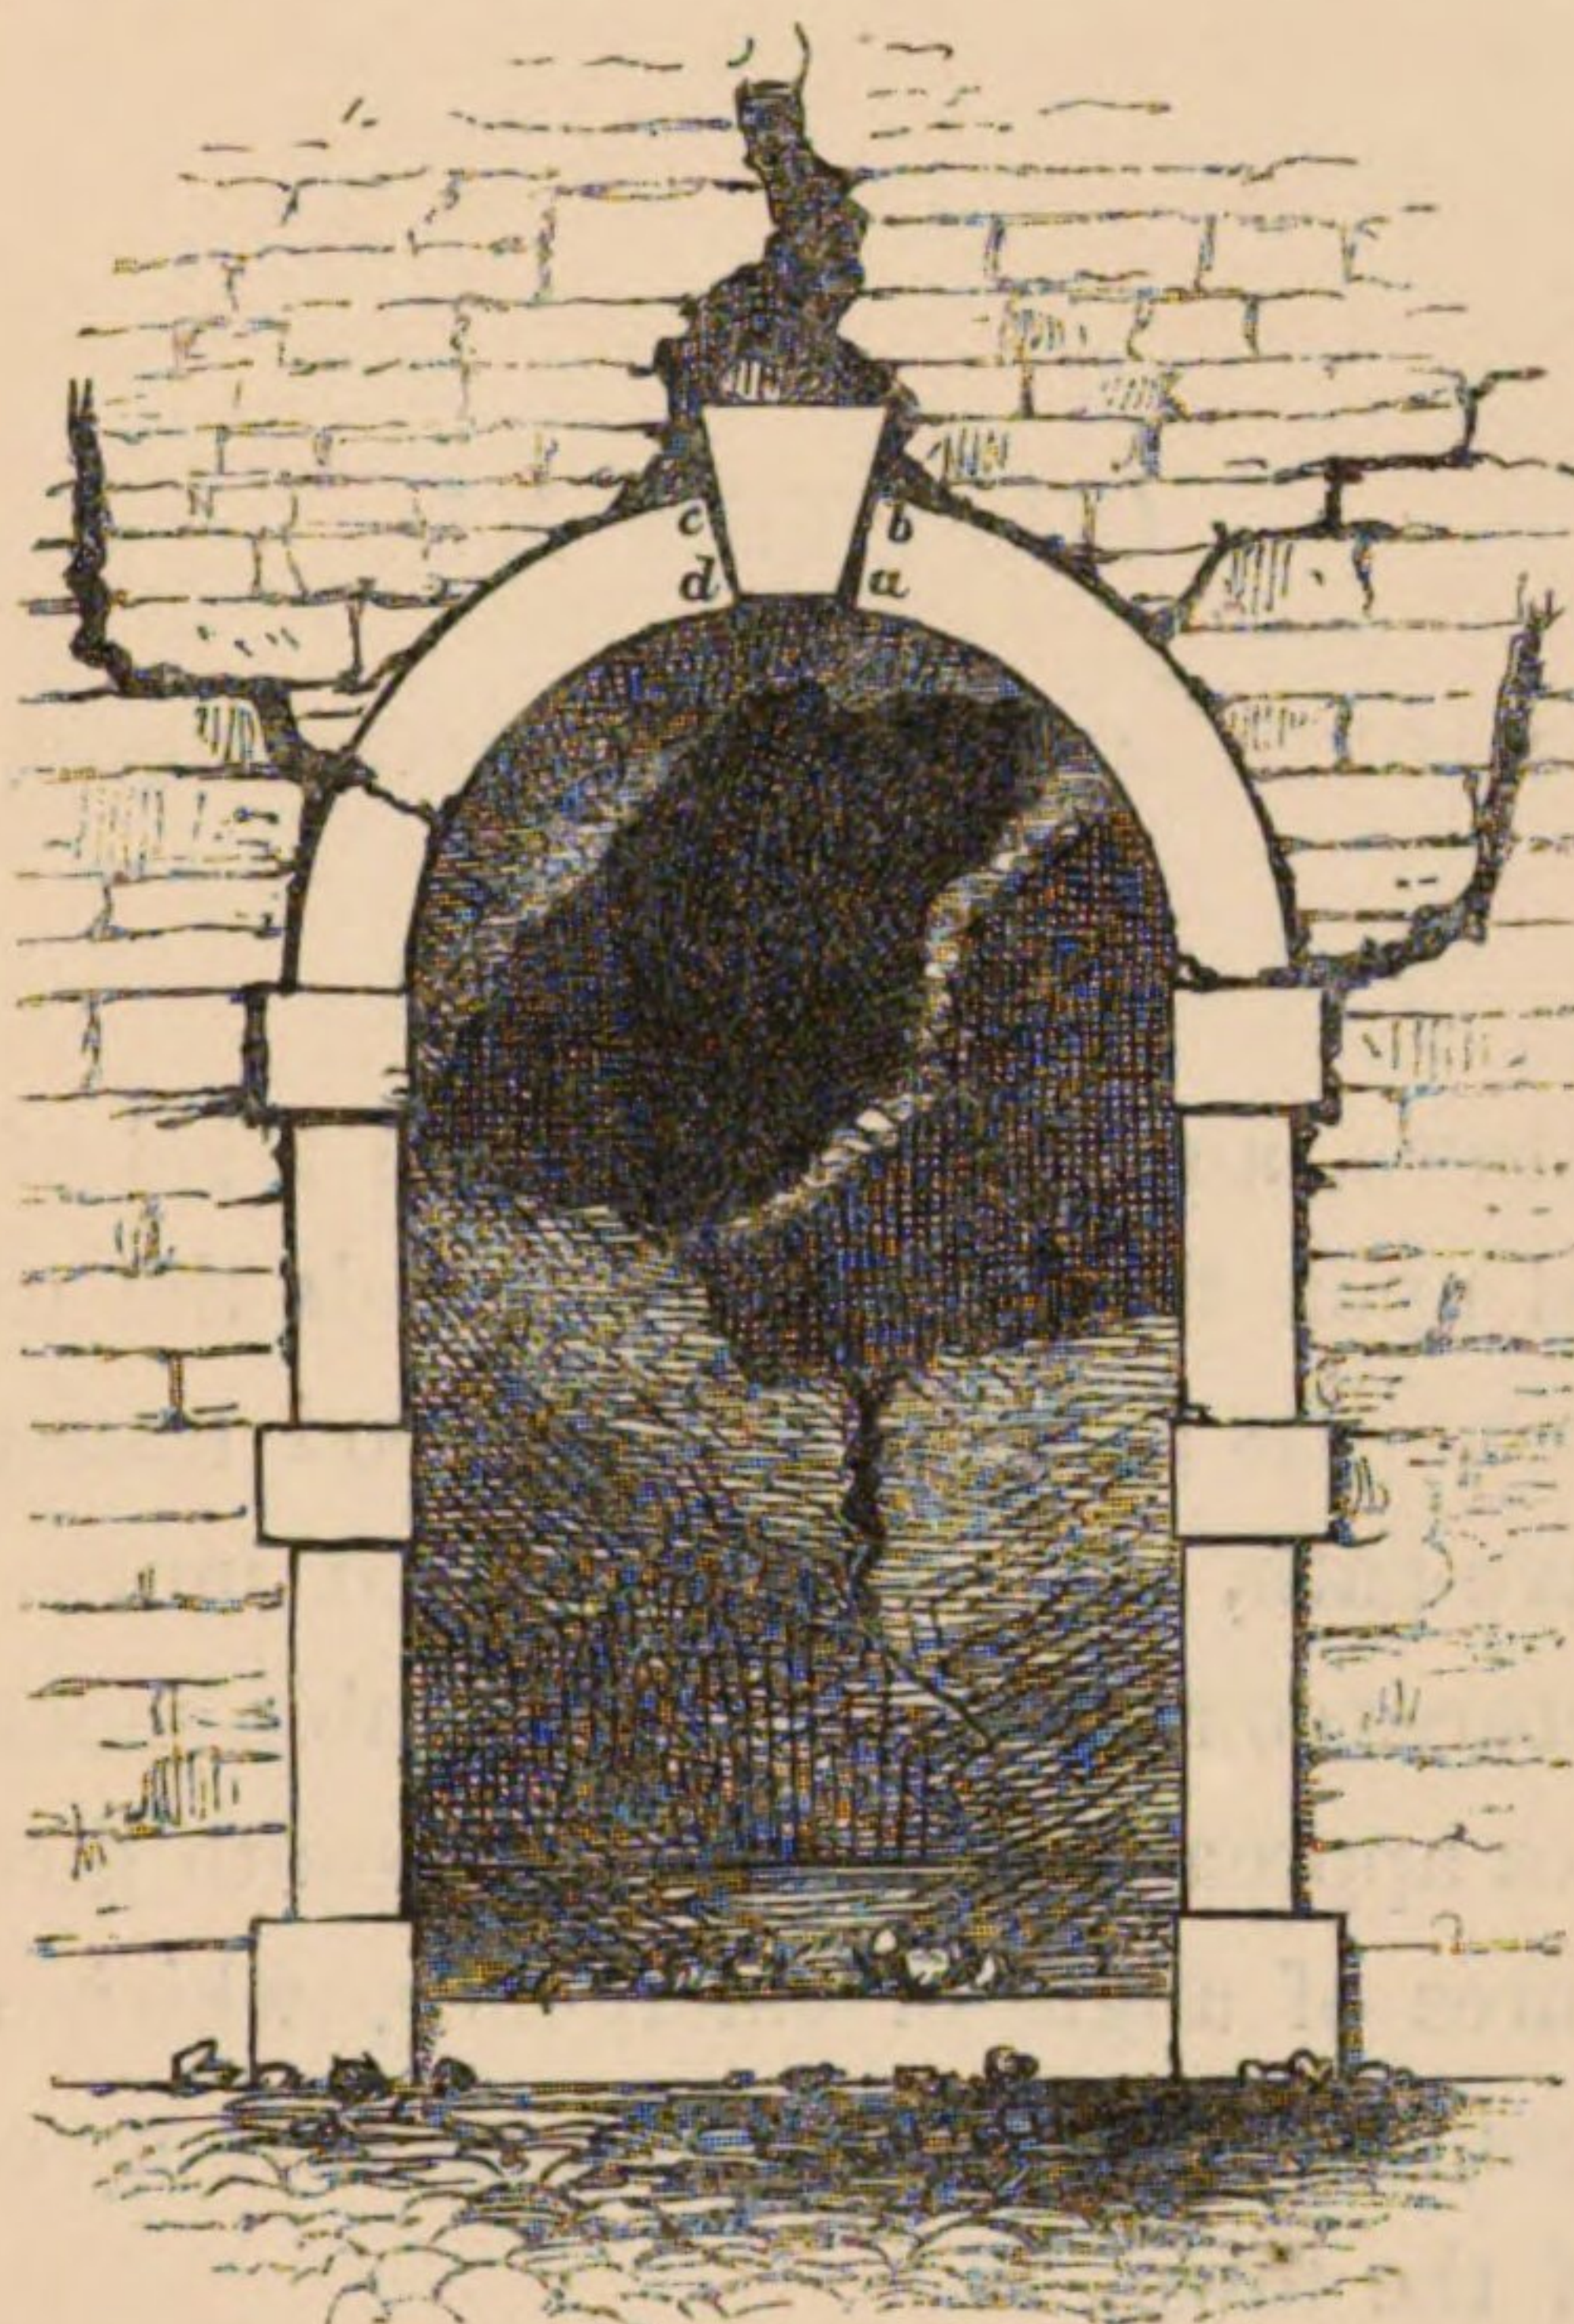
Fig. 224.

I found here also, as at Polla, an example of that singular circumstance, the keystone or block, of a cut stone semicircular arch over a doorway, which had *worked up* in place of coming down (by the movements of the earthquake) between the remaining arch stones. This case, of which the (original) Sketch No. 224 is a true representation, (though very imperfectly given by the woodcut,) is obviously due to the rocking to and fro of the whole wall in the plane of the arch, the motion being several times repeated, and hence the alternate partial freeing and gripping of the keystone, at *a* and *c*, *b* and *d*, between the rocking voussoirs, which, moving on the lowest point of the jambs, or at the springing level, are thus at each oscillation, relatively higher and lower than each other, at *d* and at *a*. The

keystone at each alternation, if already tolerably free above, by the fractures of the wall, produced at the first moment

of shock is thus moved up more or less, and finally remains at the height gained.

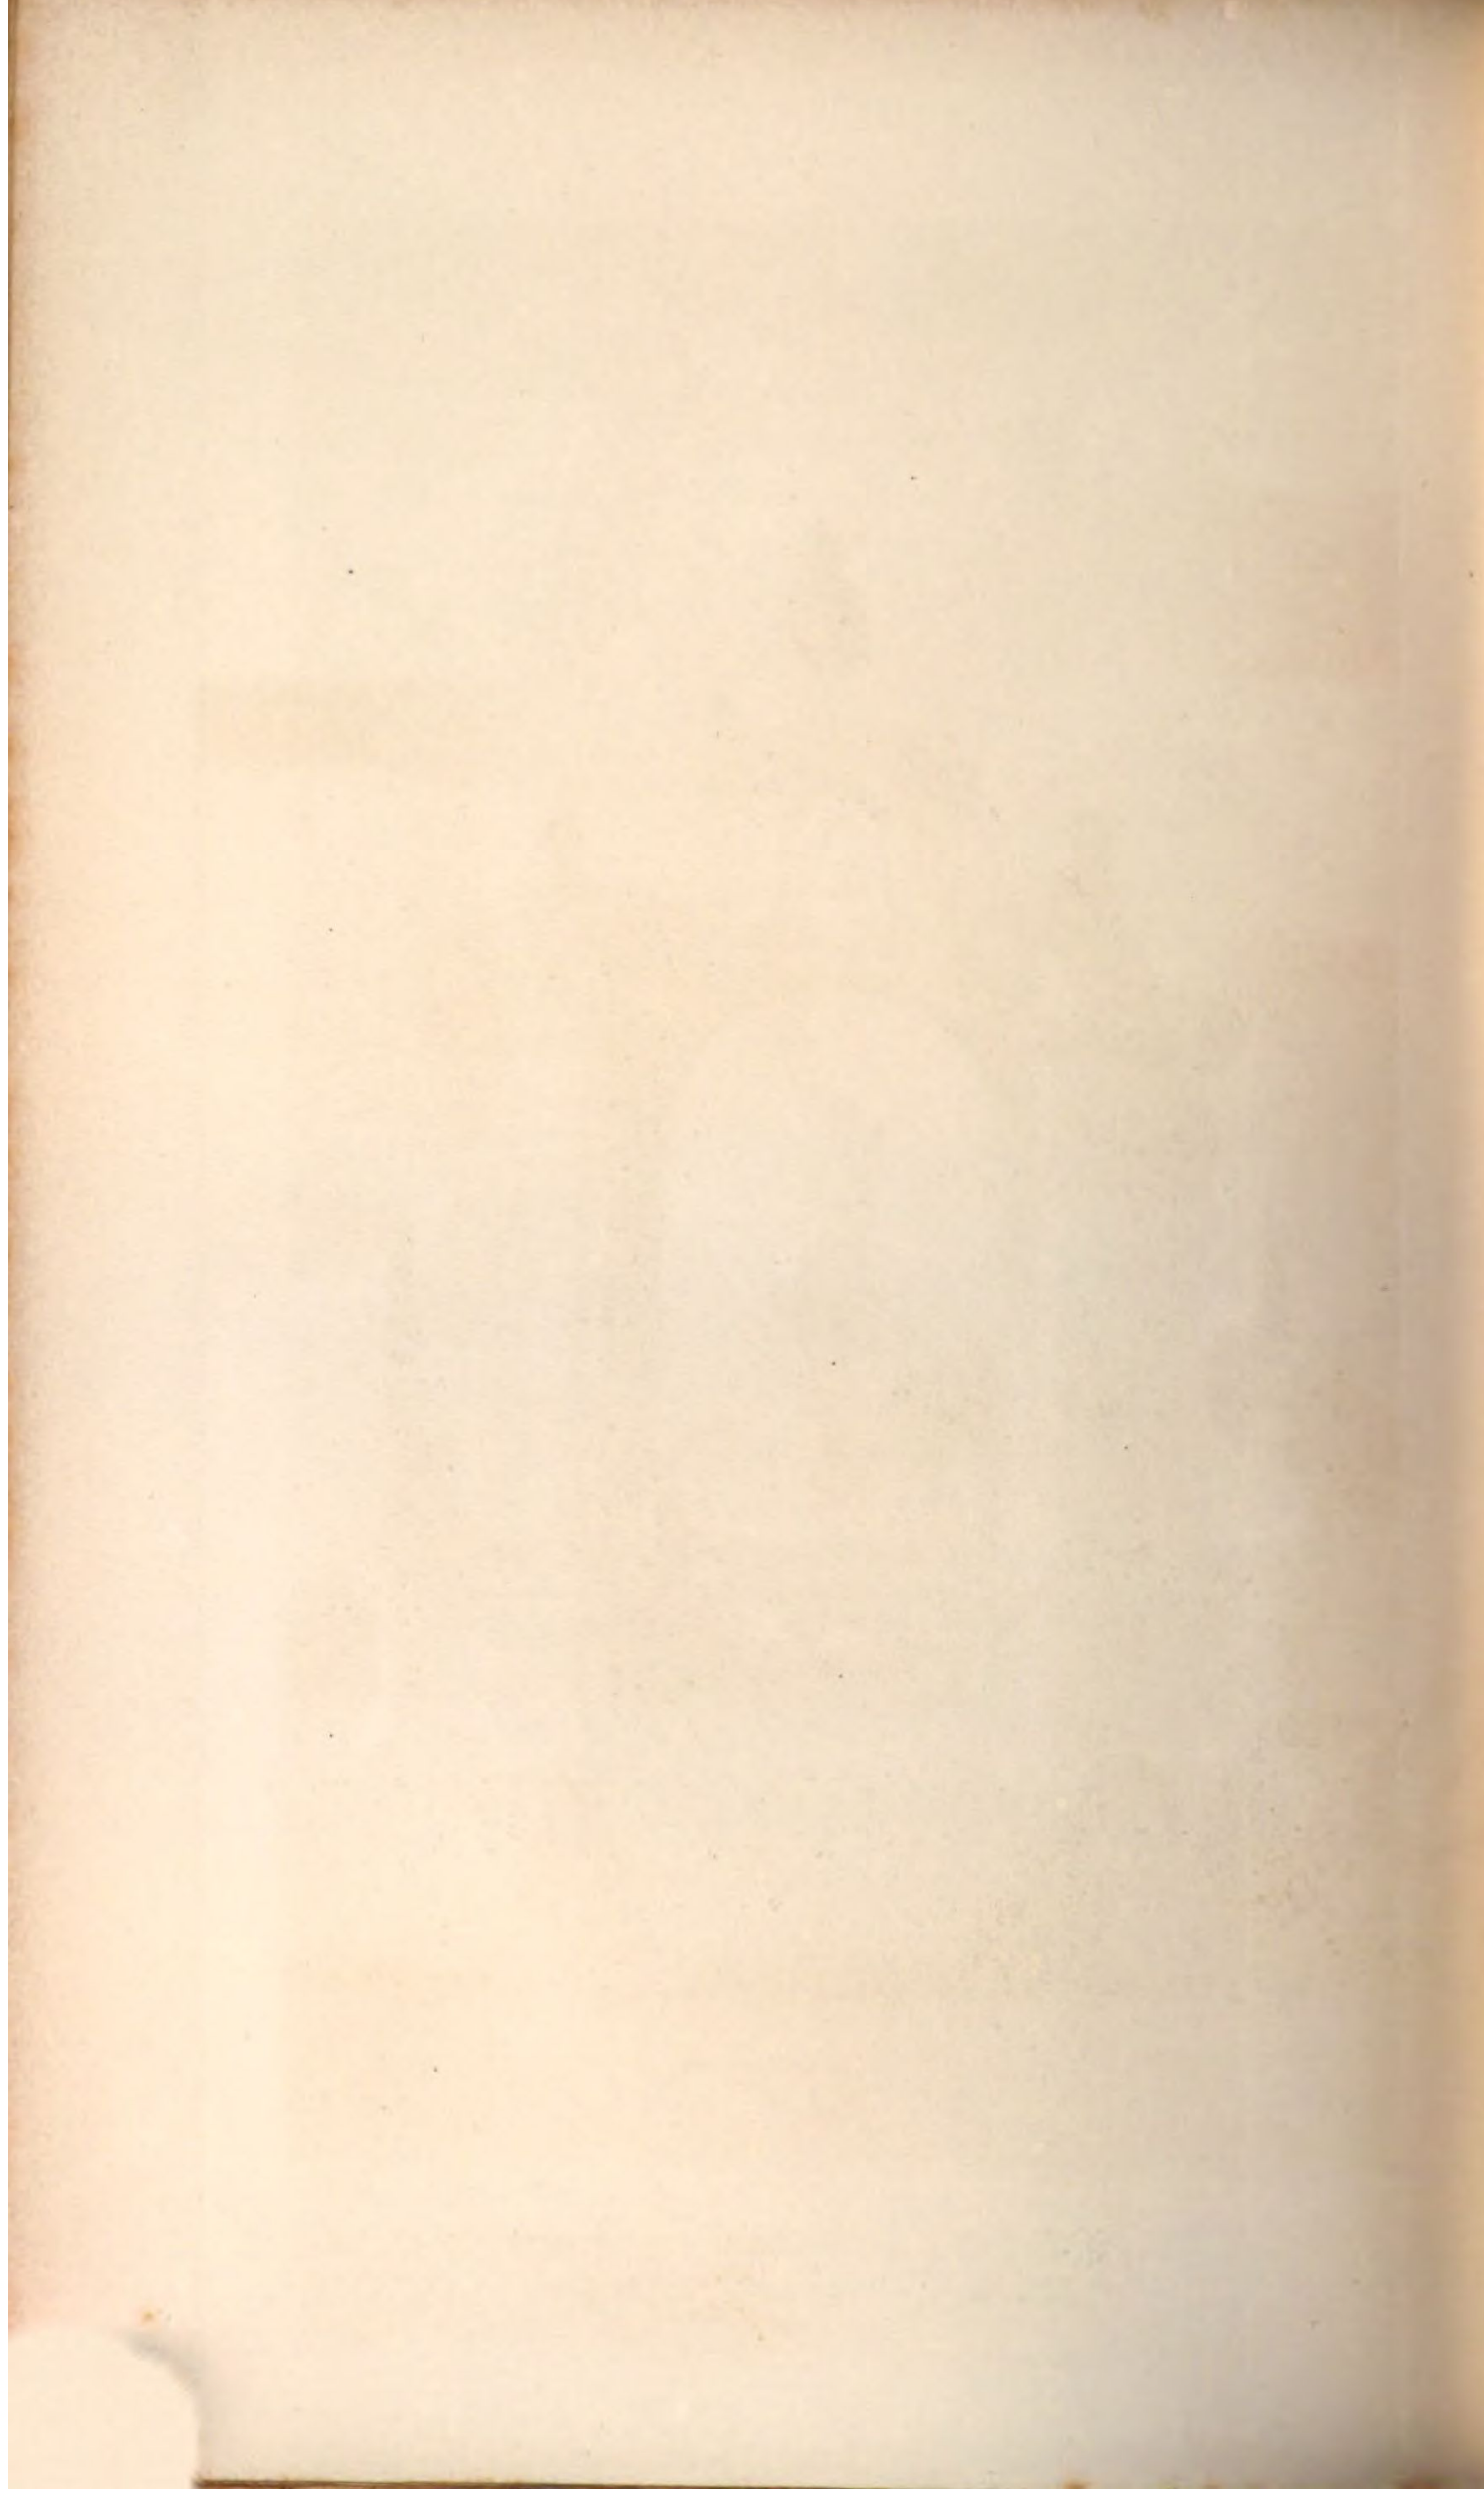
THE MONUMENT IN HONOR OF ST BERNARD,
AT THE CERTOSA, PADULA.

Opposite the front entrance gate of the monastery, at D, (Diagram No. 240,) but at a considerable distance to the south beyond what the diagram admitted, stands a monument to St. Bruno (Photog. No. 225). The general plane of the structure runs east and west almost exactly. Several of the little obelisks and finials upon it, have been twisted from left to right (looking south at it), or in the same direc-

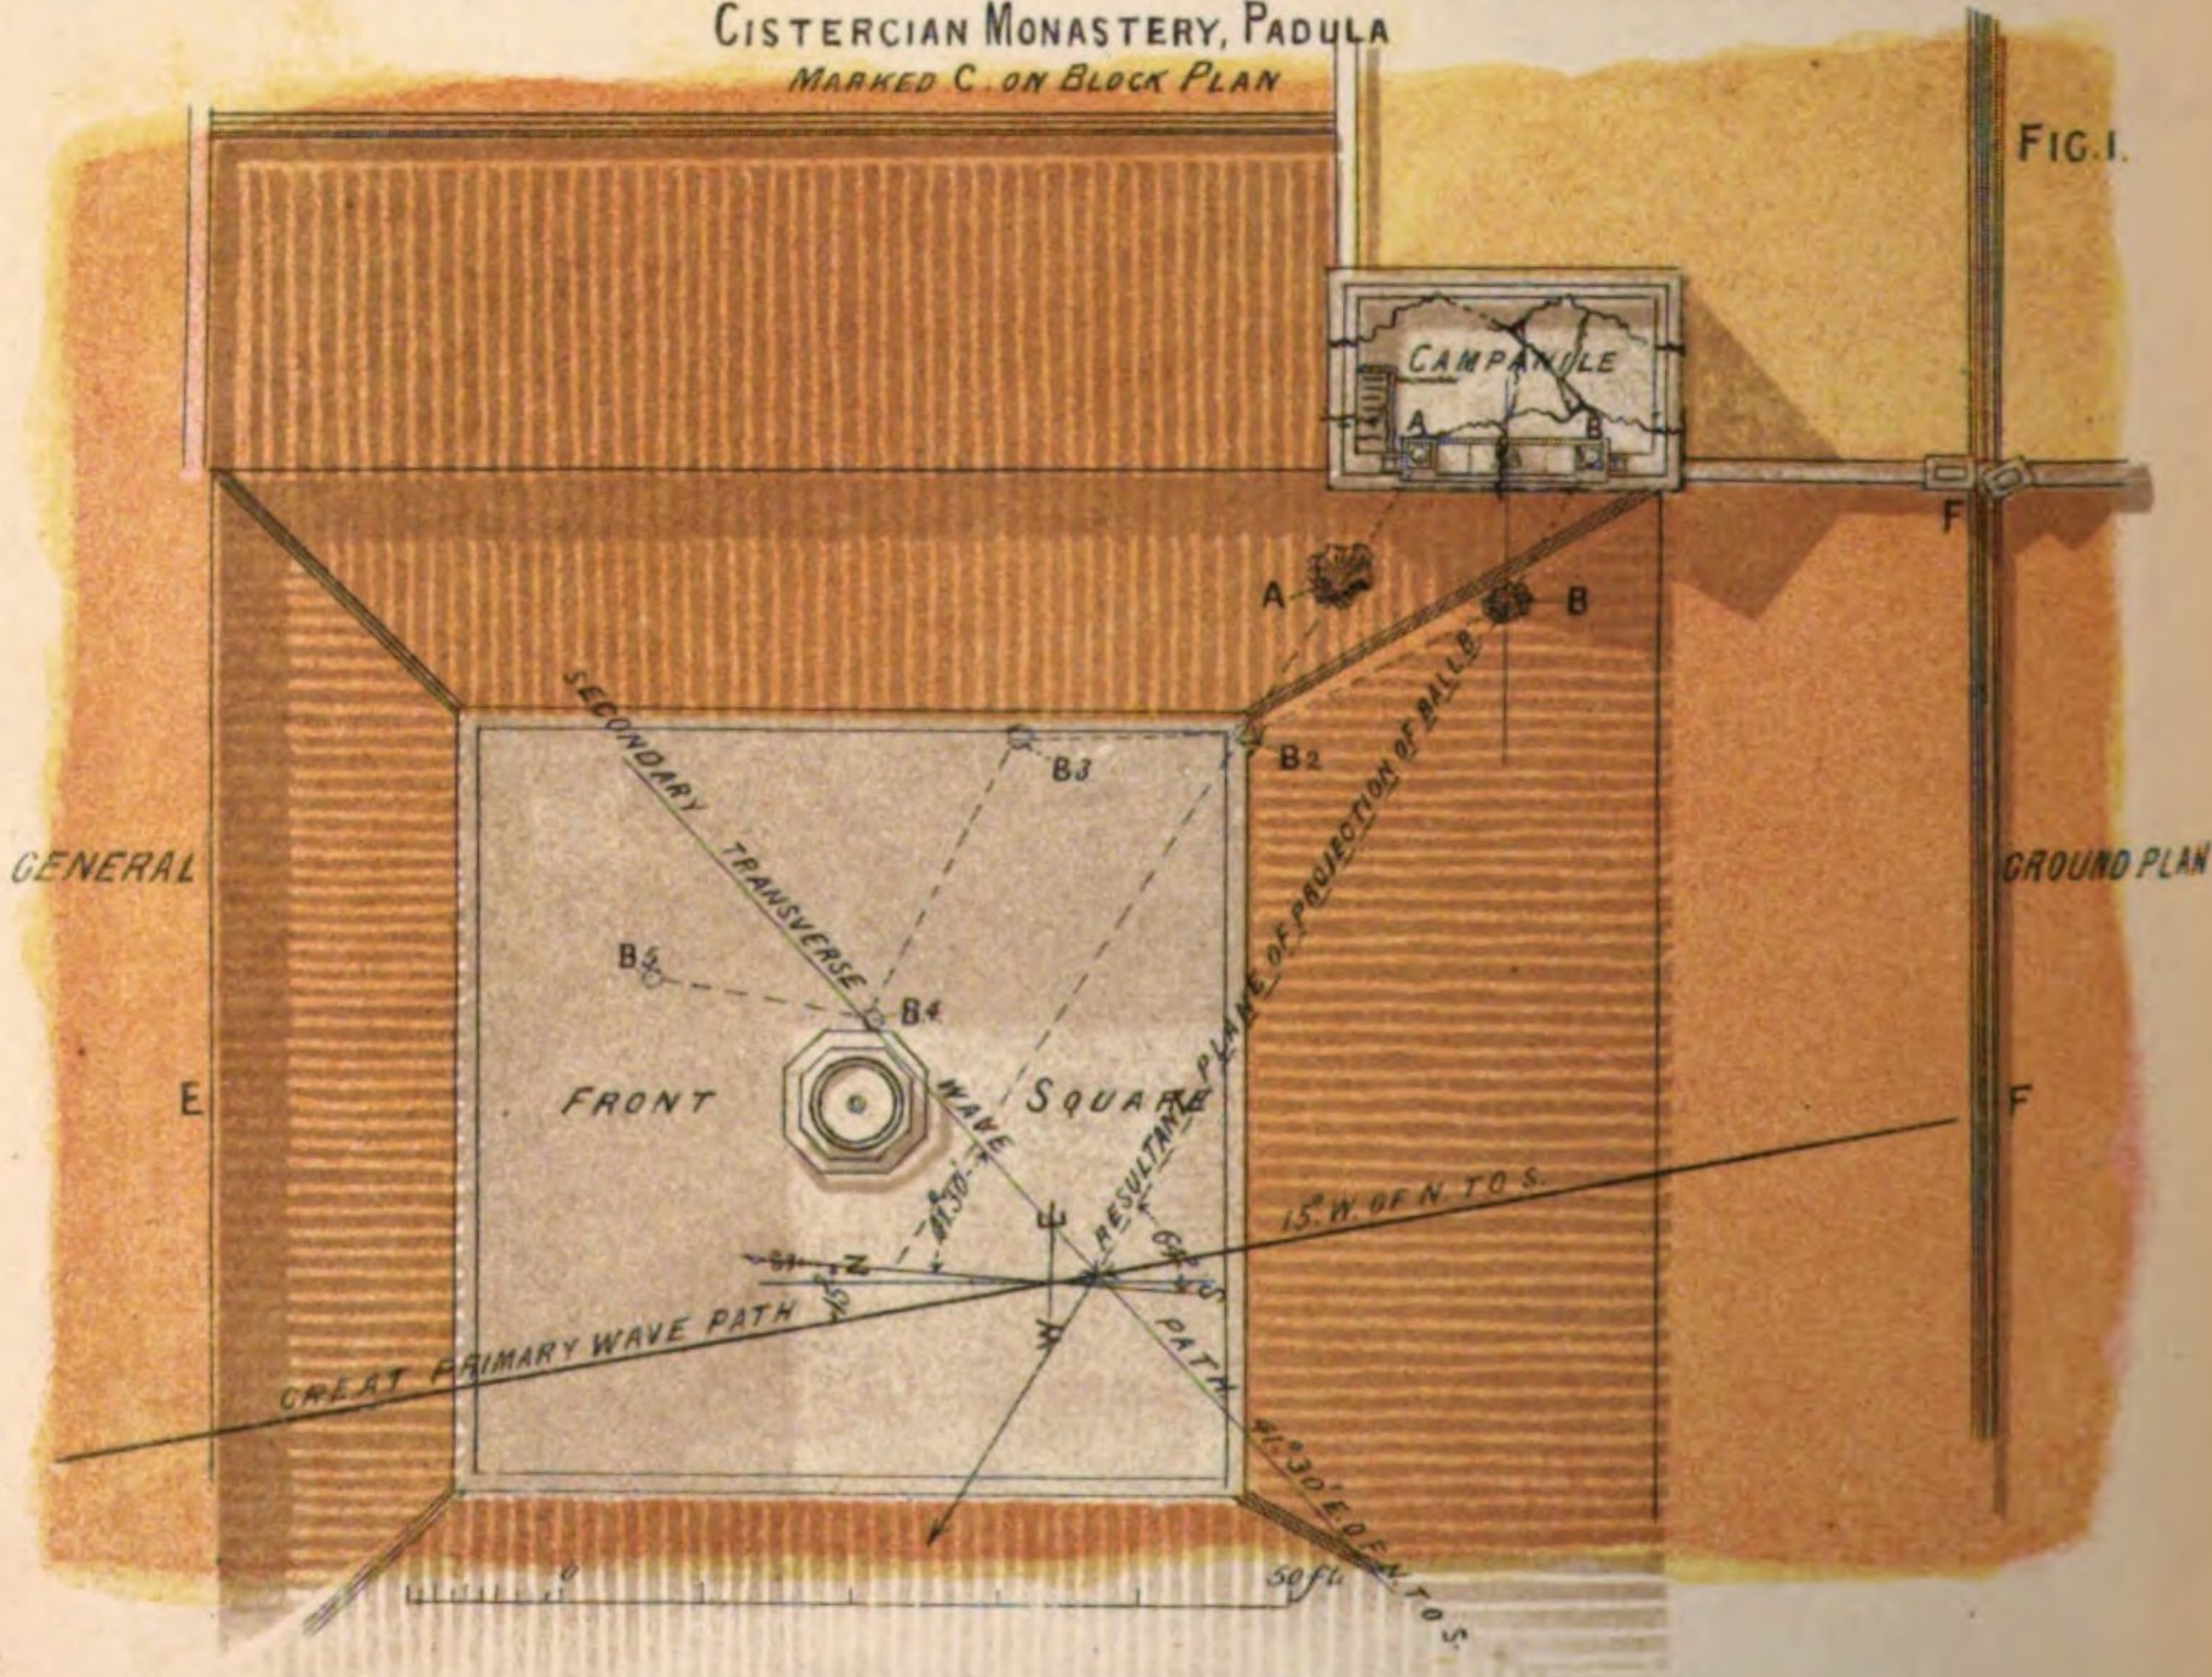
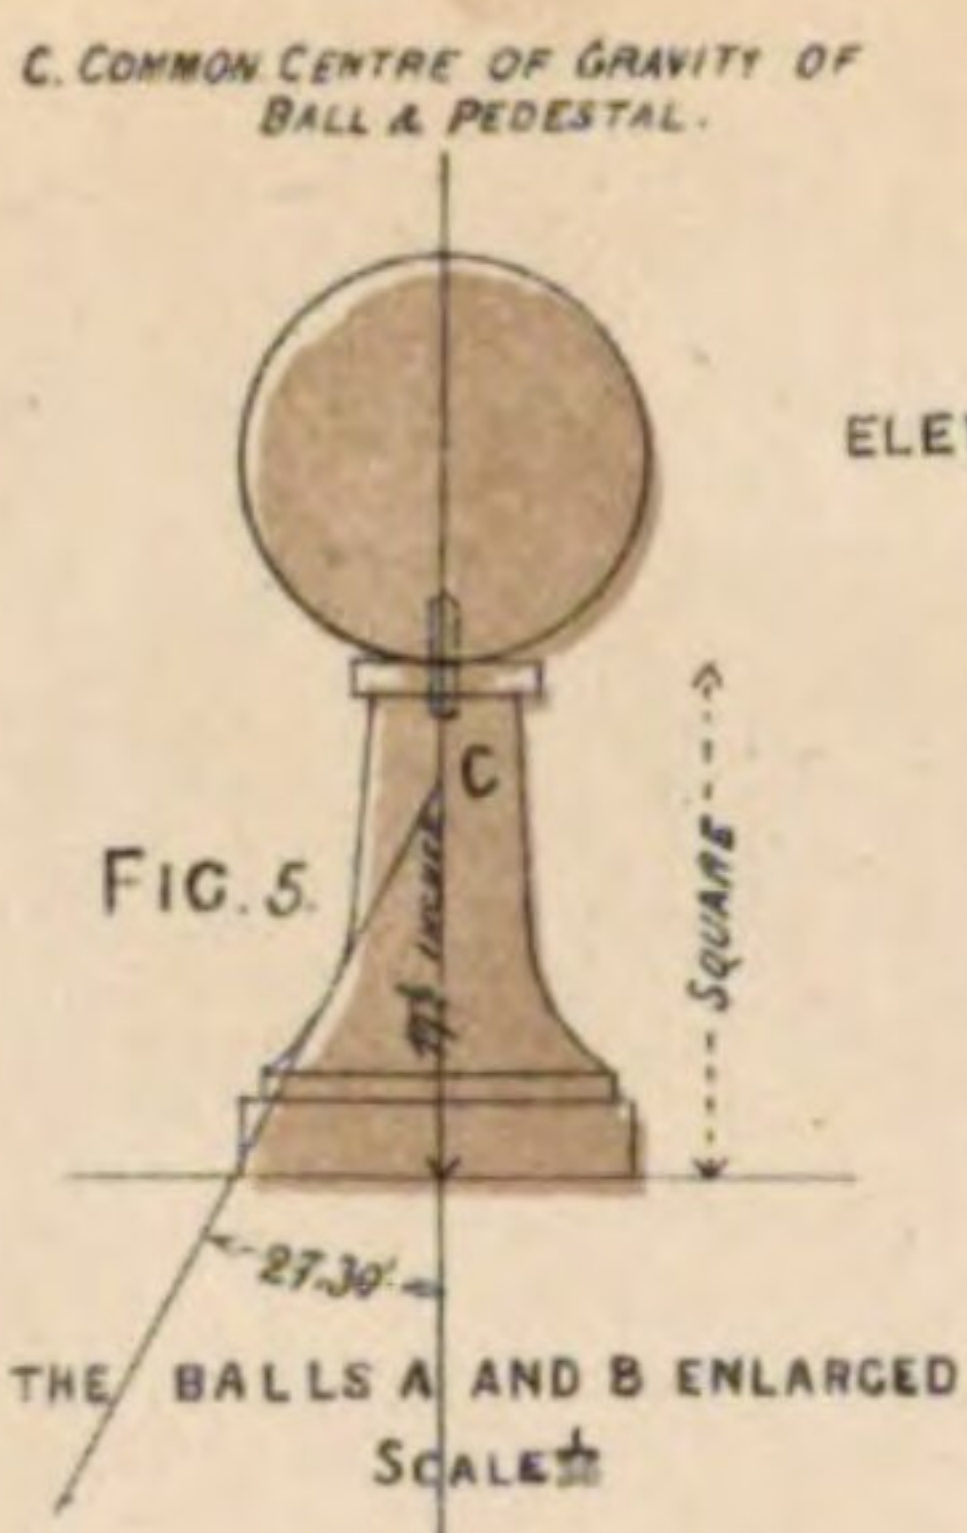
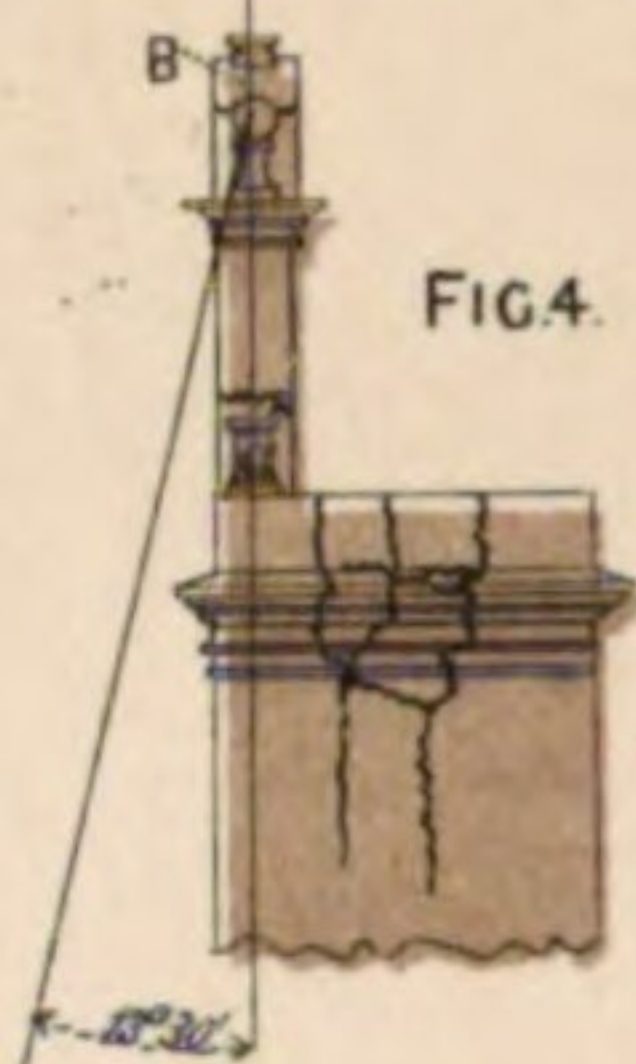
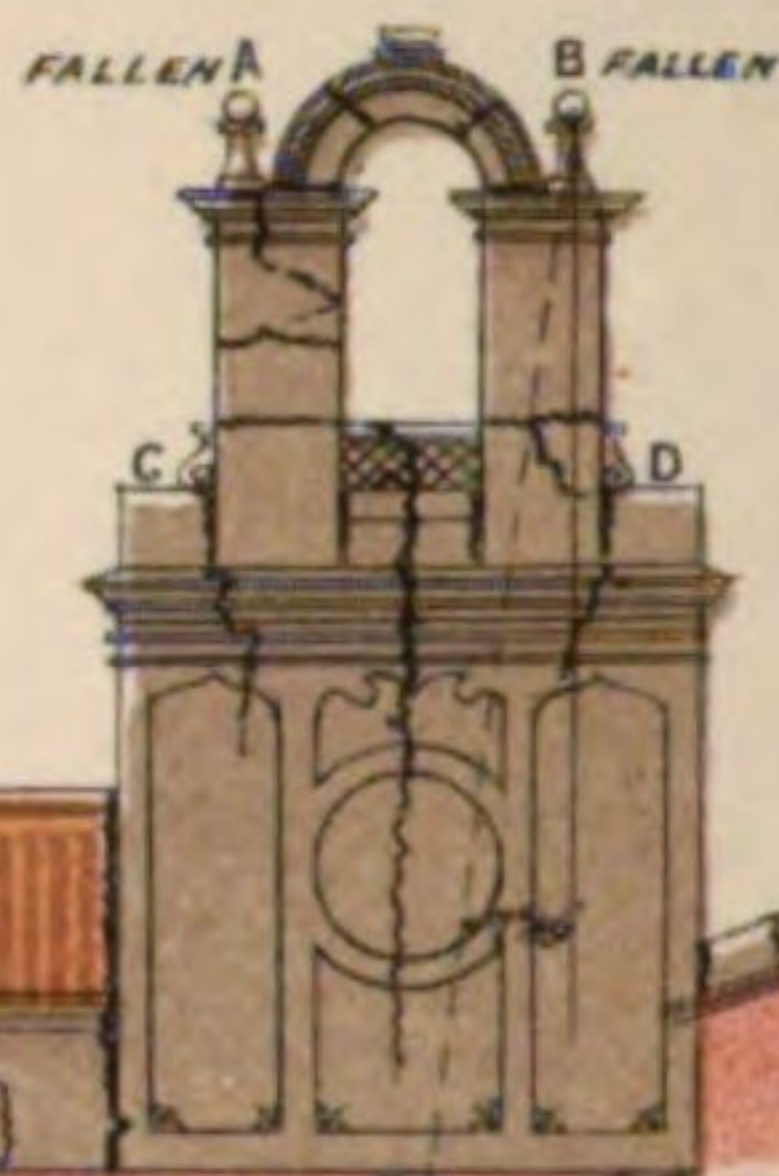
Drawn Pl. 238

Very near the Campanile, but far below its summit level, upon the east gable of the front range of buildings, at F (Fig. 1, Diagram No. 238, and Fig. 4, Diagram No. 240), are two remarkable chimney stalks, one of which has been twisted upon its base, at a horizontal fracture close to the level of the gable, the other standing uninjured.

We shall take the velocity from the ball B, which fell unencumbered by its base, and whose mark where the sphere struck and fractured the tiling of the roof, at B, (Fig. 1, Diagram No. 238, and Fig. 2, Diagram No. 240,) left no doubt as to its precise range.

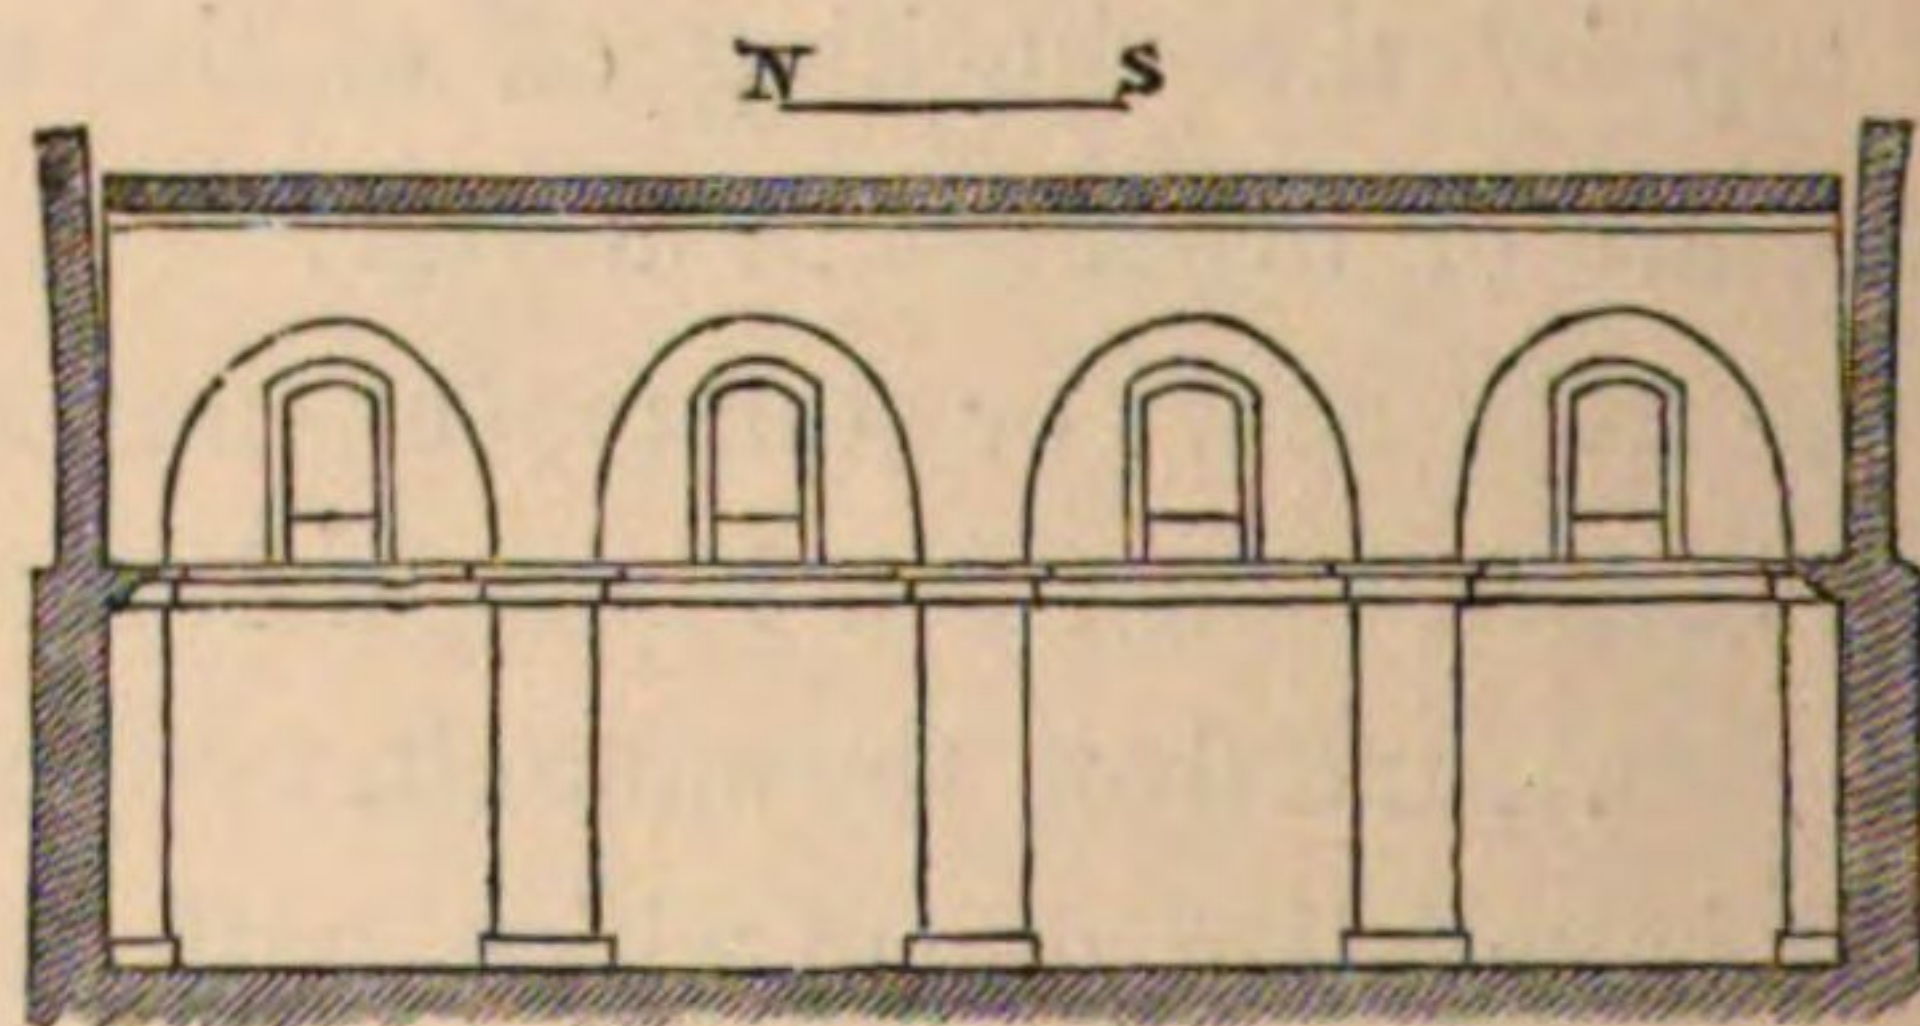
Fig. 239.

To the eastward of the front square, the roofs of the church, and of the grand refectory, groined and arched buildings of great magnitude, have been heavily fissured. In the refectory both end gables, (Fig. 239,) run up originally against the ends of the brick vault, have parted off from it, and pre-

sent east and west fissures, open 3 inches at top on the north, and $1\frac{3}{4}$ inch at the south end, while longitudinal fissures of half an inch to one inch wide run north and south along the soffit. The roof of the church is still more dislocated; both roofs are brick vaults. At the upper end of the refectory the great fresco by Elia, of the Marriage of Cana, is fissured

The gables were great semicircular walls of rubble stonework, run up from the chord-line or level of the springing, after the vault had been turned, and merely closed in against the ends of the arch, as in Fig. 239, not being bonded into it. Each of these gable walls had gone out at top from the end of the vault, producing a gradually widening and tremendous fissure, which, at the north end, was open 5 inches at top, and at the opposite, or south end, 3 to $3\frac{1}{2}$ inches.

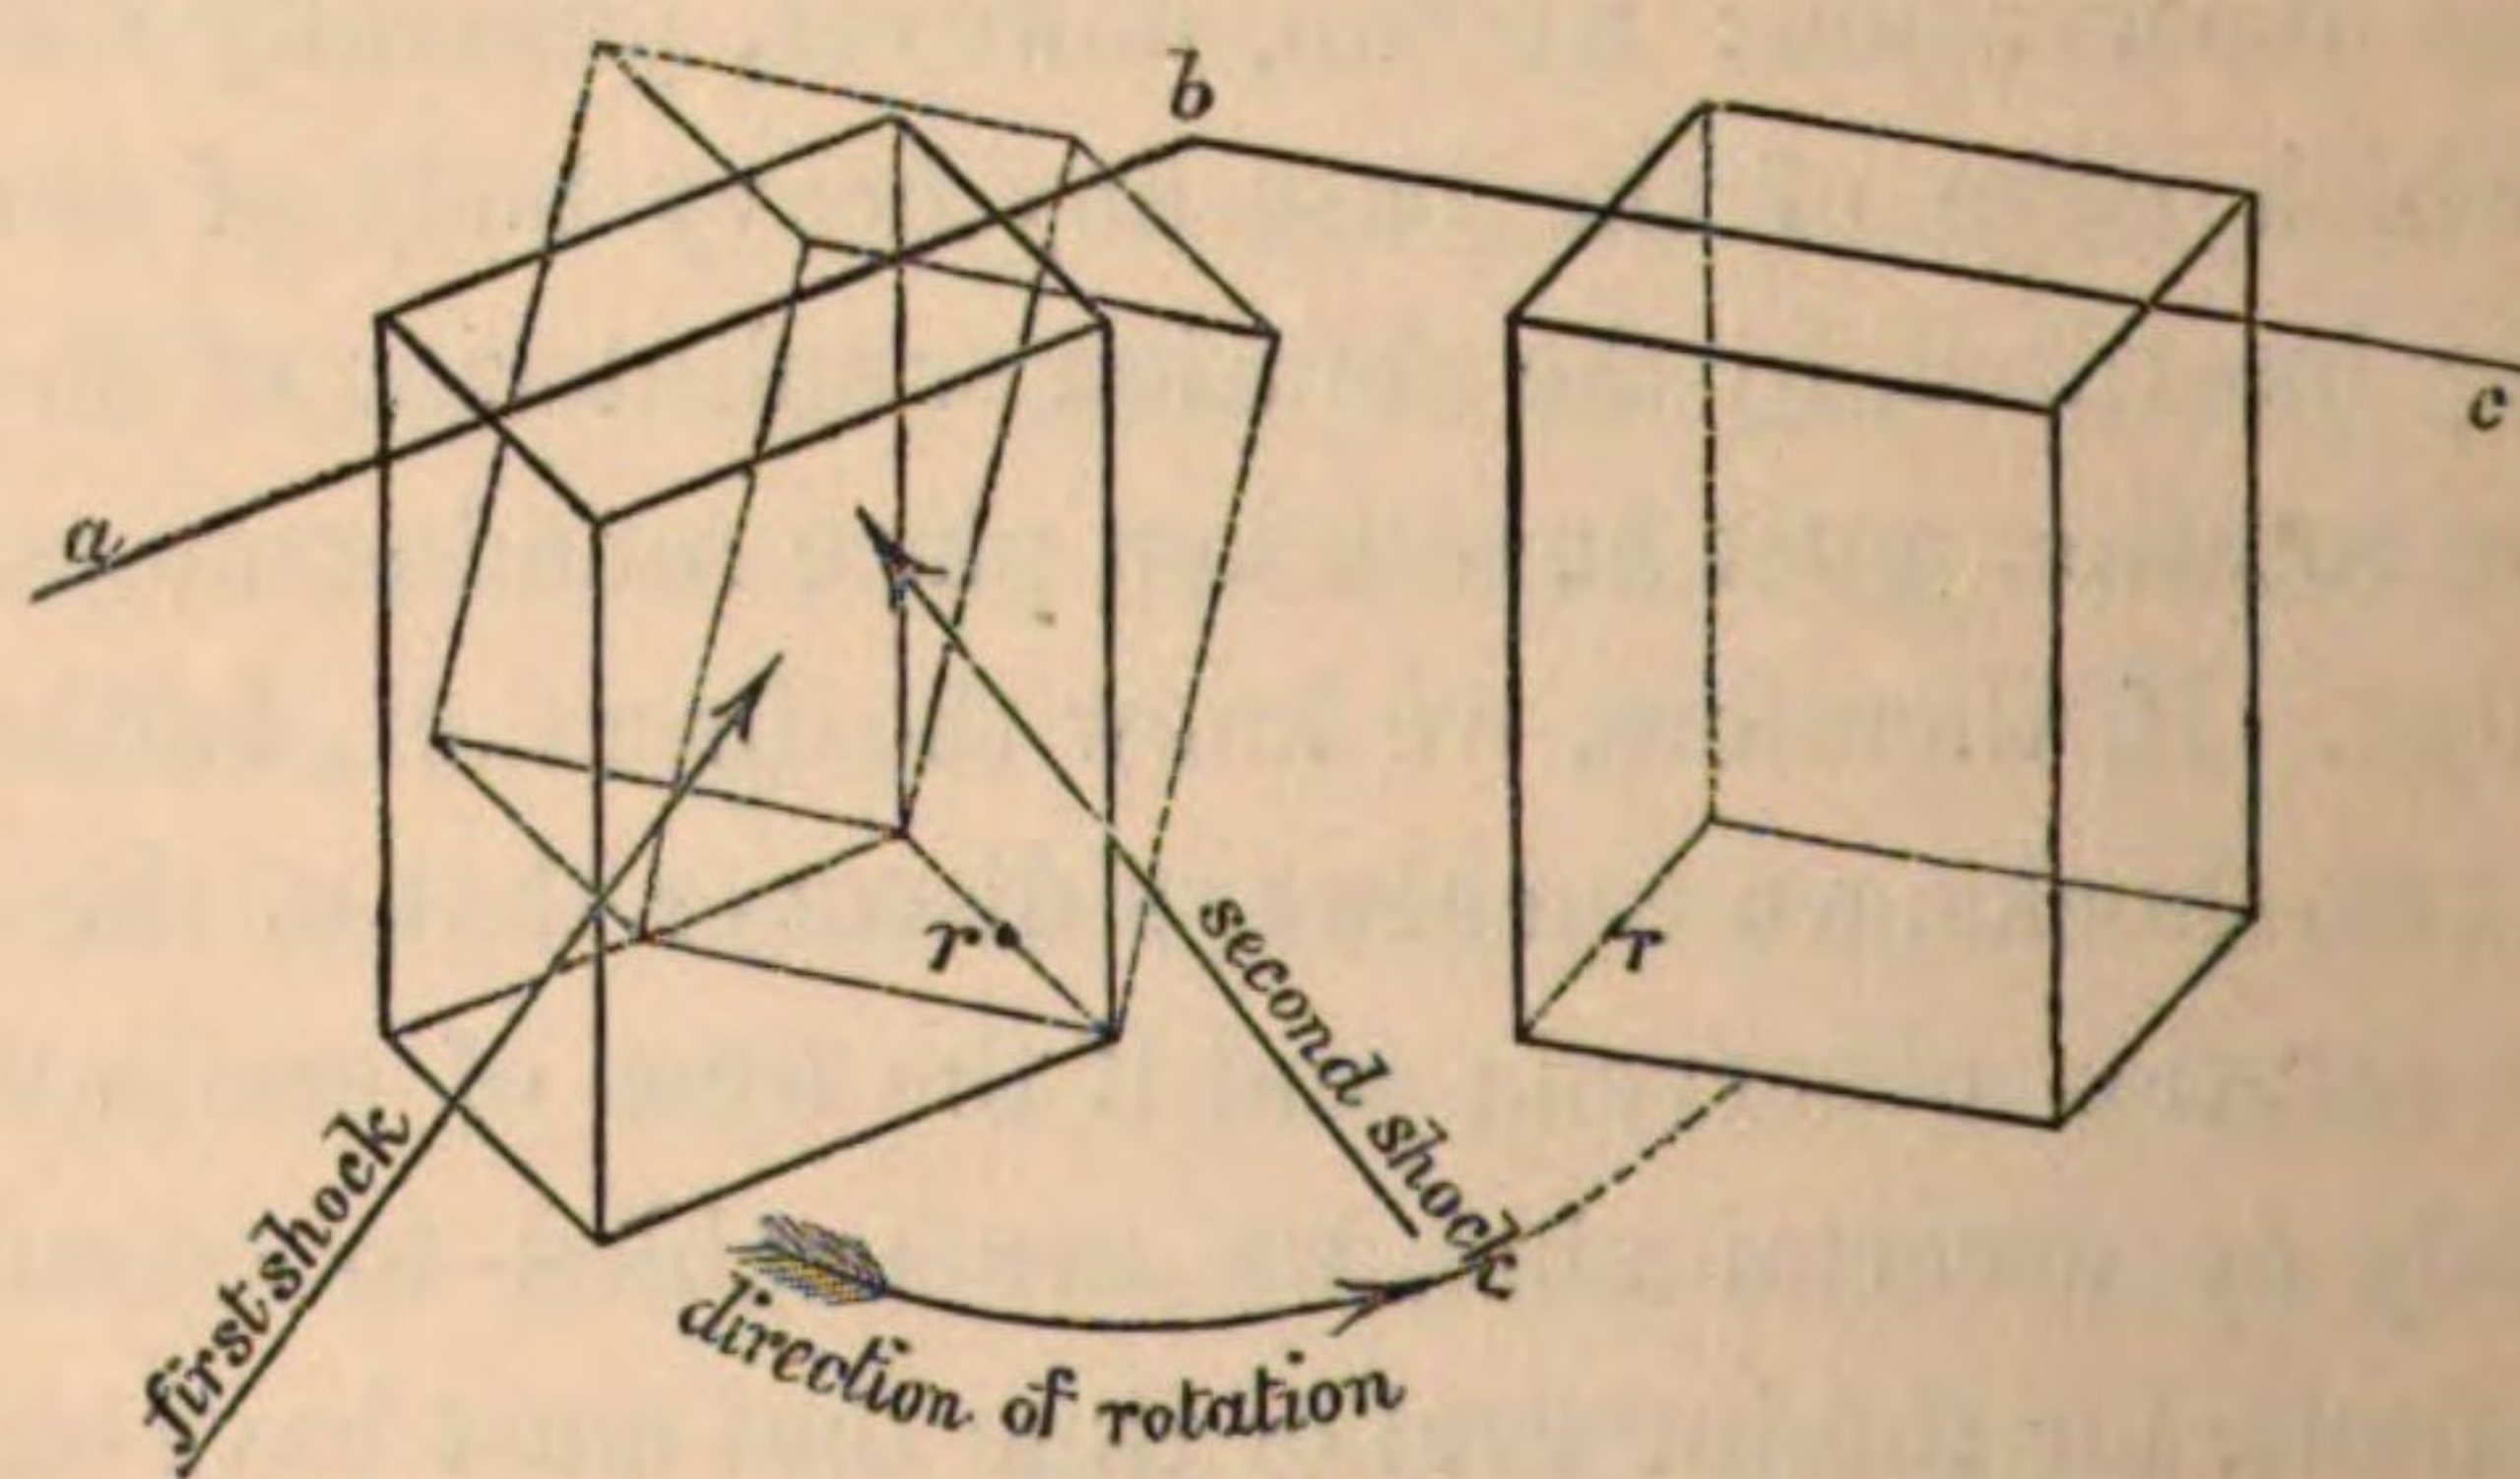
Fig. 235.

All the effects of the double shock will be understood by examination of the Figures Nos. 235 and 236, in which

Fig. 235 shows the action of any double shock; Fig. 236 the variations of result produced, first, by rotation in the first
